# Manhole Inspection Summary

Manhole # S02AA2042MH

**Location** Address: **3403 BANCROFT RD**

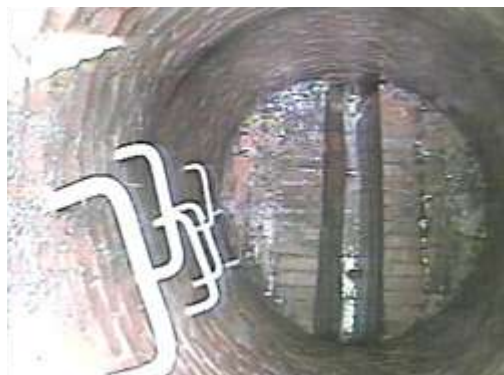
Top View

**Bench** ☒ Exists Material: **Brick** ☐ Parged ☒ **Debris** (not Condition related)

**Steps** Count: **3** Missing: **0** ☒ **Corroded**

Corroded steps. Bench debris.

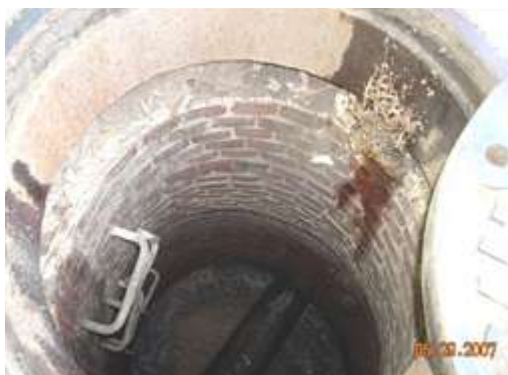
Defect

Infiltration: ☐ None ☒ **Joint** ☐ Cracks ☒ **Mortar** ☐ Roots ☐ Wall

Infiltration: ☐ None ☐ Joint ☐ Cracks ☒ **Mortar** ☐ Roots ☒ **Wall**

Adjustment and Barrel infiltration. Cover inflow.

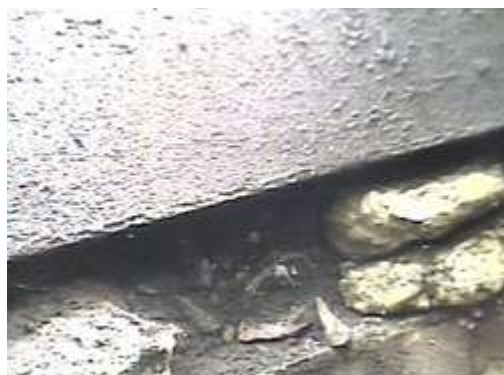
Defect

Frame leaks. Adjustment deterioration, root intrusion, loose brick and infiltration.

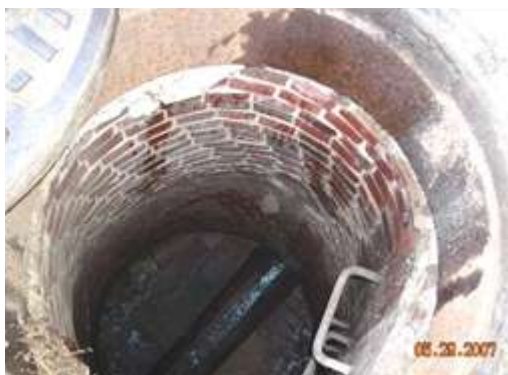
Defect

Adjustment and Barrel infiltration - other side.

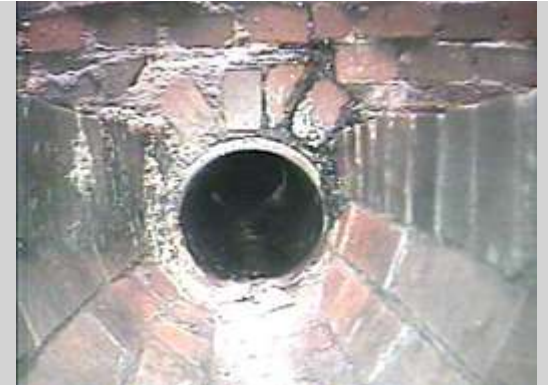
### 8 in. Circular Gravity Sewer Pipe Out @ 12 O'Clock

Deposits: ☐ None ☐ Mud ☐ Sludge ☐ Debris ☒ Grease

Silt Depth: **0** (in.) Deposits Extent: **Light**

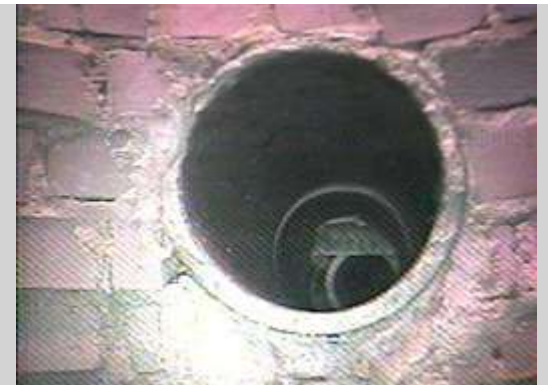
### 8 in. Circular Gravity Sewer Pipe In @ 6 O'Clock

Infiltration: **Evidence** Pipe Seal Cond: **Cracked**
